Marginal gap and fracture resistance of implant-supported 3D-printed definitive composite crowns: An *in vitro* study

Objectives: To compare the marginal gap and fracture resistance of implant-supported 3-dimensional (3D) printed definitive composite crowns with those fabricated by using 3 different millable materials.

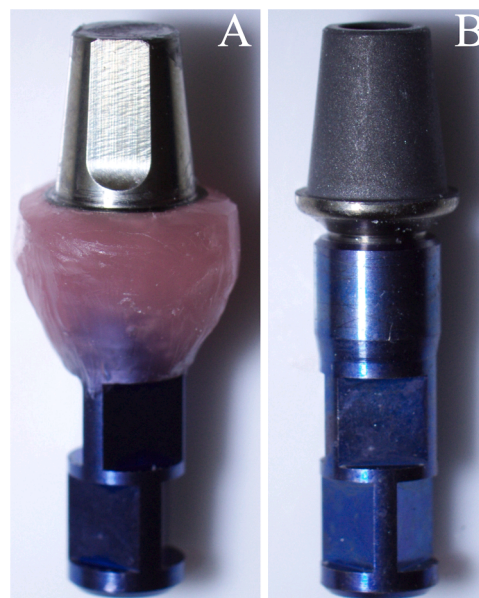
Fig. 2. Pretreatment of the standard abutment (A: Isolation of the margins; B: After sandblasting).

Crowns were then pretreated either with airborne particle abrasion (Rotaks Sandblasting Machine; Rotaks Dent, Istanbul, Turkey) or hydrofluoric acid etching gel as per manufacturers' recommendations for adhesive cementation (Table 2). After isolating the abutment margins with wax, the abutments were sandblasted with $50 \mu\text{m Al}_2\text{O}_3$ from 10 mm for 60 s (15 s per surface) at 1 bar (Fig. 2) [27].

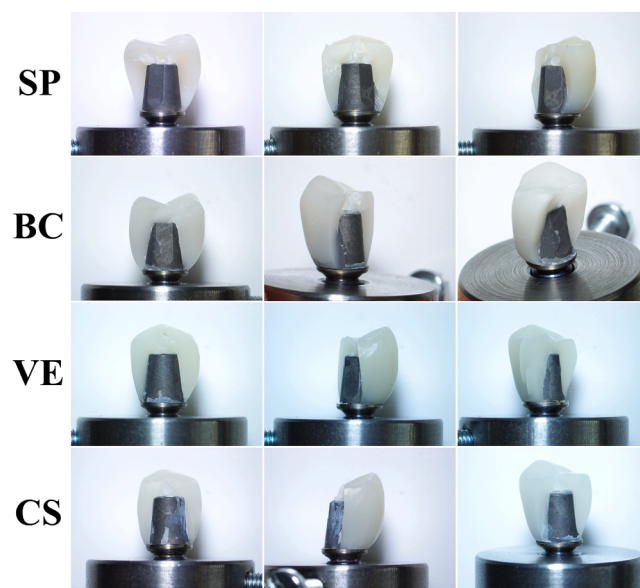
Fig. 4. Crown fractures observed in each group.

Table 5 summarizes the descriptive statistics of the fracture resistance data. One-way ANOVA showed that the differences among the test groups were nonsignificant ($df=3, F = 1.589, P = .209$). In addition, all crowns showed non-repairable fragmented crown fractures with at least one part of crown remaining on the abutment. However, no damage was observed in any of the abutments or prosthetic screws (Fig. 4). Fig. 5 illustrates the representative SEM images of the tested materials for fractographic analysis. Fractured SP, BC, and CS surfaces showed similar topography, which was characterized by dominant hackle and arrest lines. However, VE surfaces were relatively smoother when compared with the other materials tested.
